Troubleshooting

No Flush C402C

No Flush C402X

No Flush C403L

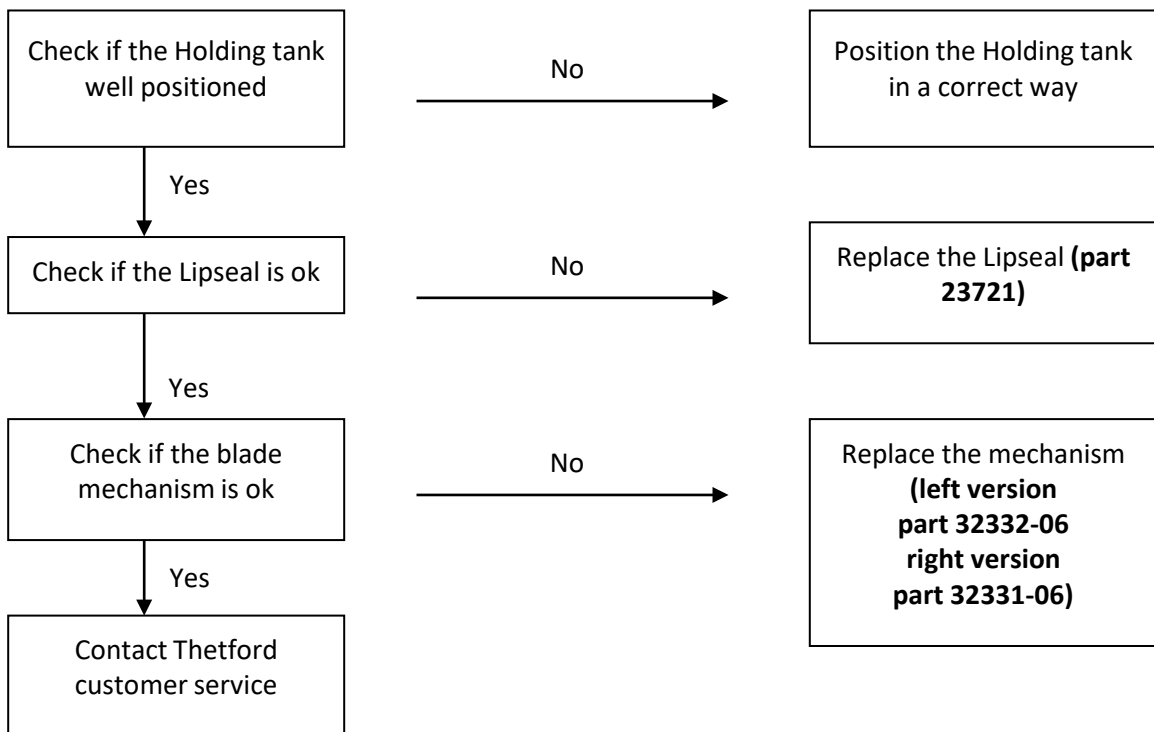
➤ Leakage between the bowl and the Holding tank

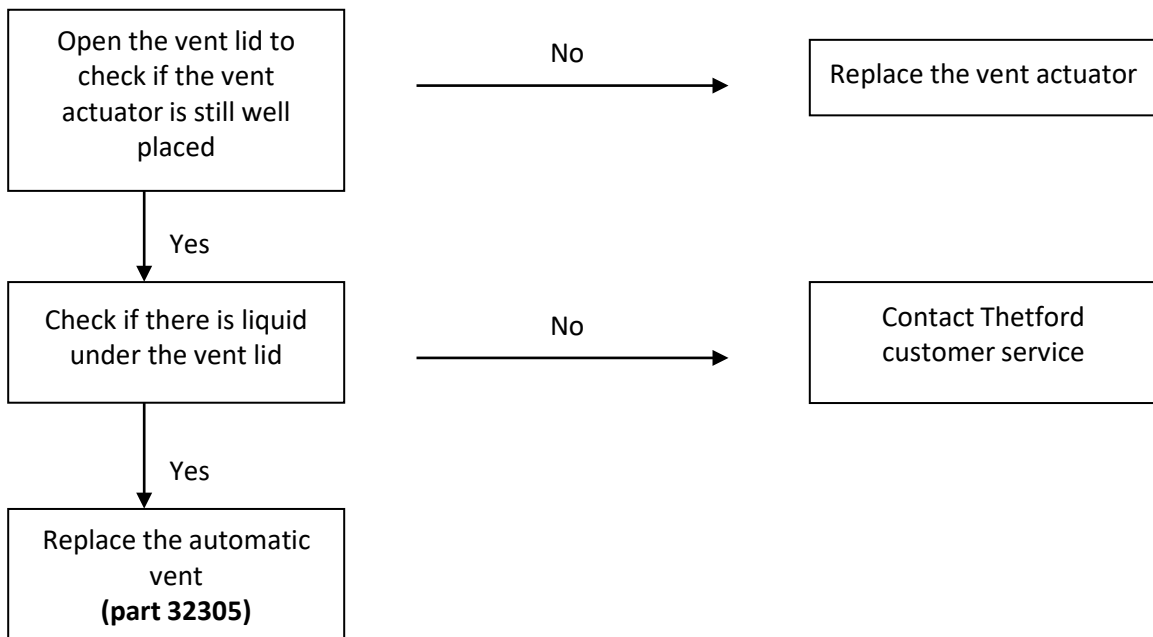
▪ **Leakage at the vent lid**

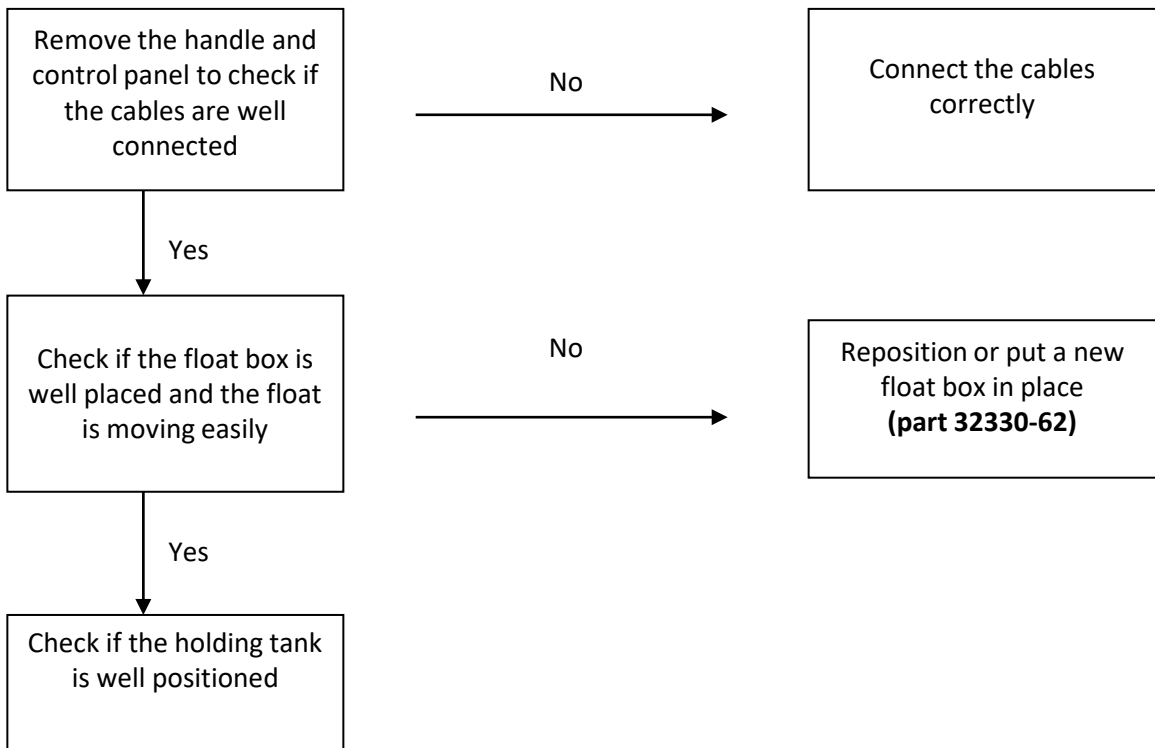
No level indication of the C402X Water tank

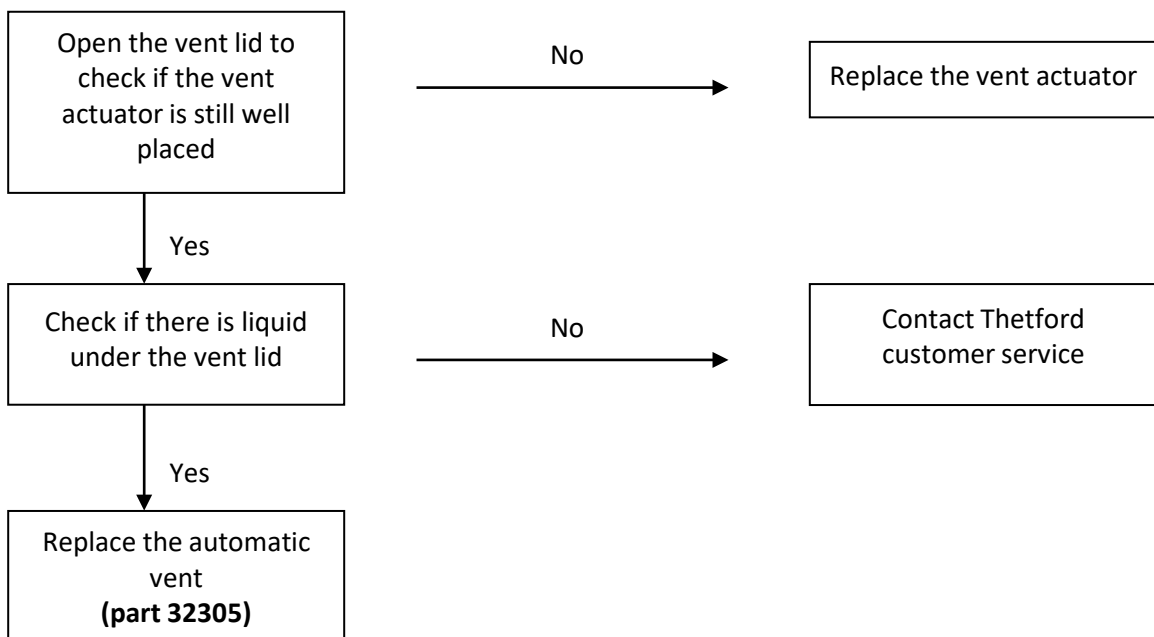
- Leakage at the vent lid

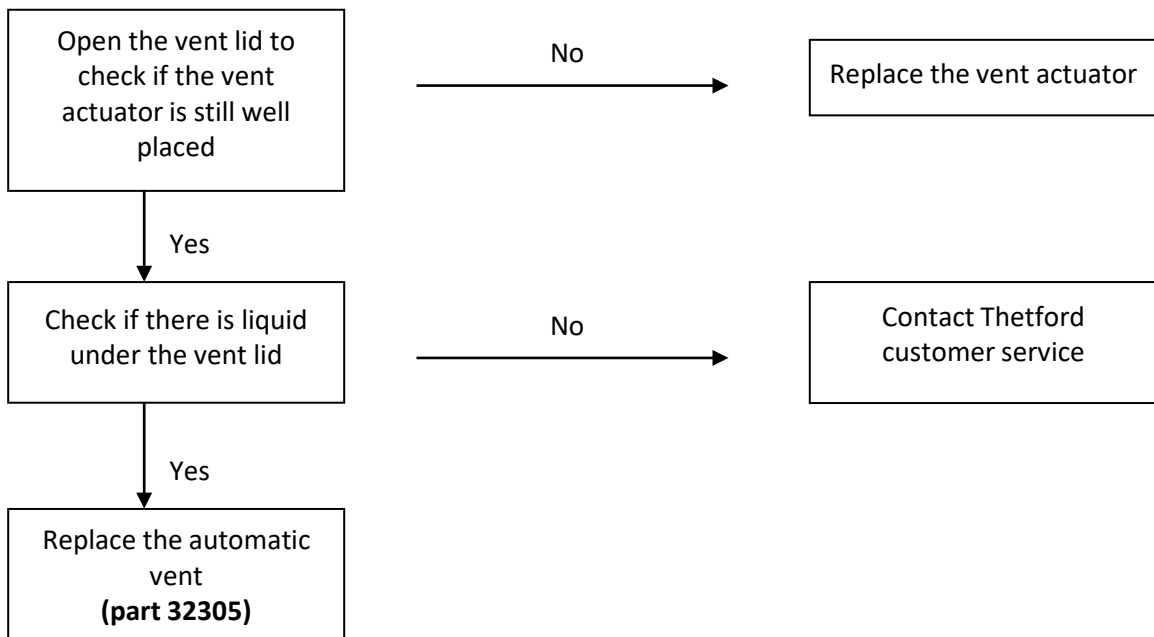
- Leakage at the vent lid
