Repair instruction

Description: SPP Level indicator FWT Excellence	
Part number: 92405-111/60/130/135	
Look for Service Centres, Point of Sale addresses and other information on: www.thetford-europe.com	
Version:	1
Date:	January 2012
	—

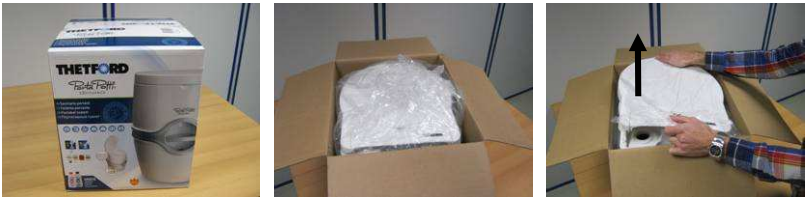
A

Open outercase, put plastic on the side and pull seat & cover off.

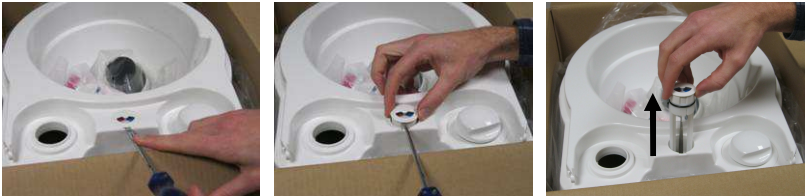
B

Place flat screwdriver under level indicator, lift it up and take complete level indicator out.

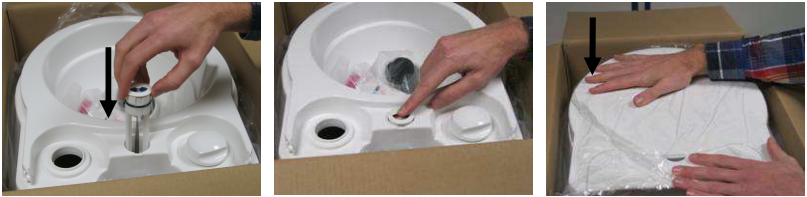
C

Place new level indicator, press it in and place seat & cover back.

Note: it can happen that only the cover of the level indicator comes loose, use a nose plier to pull out the rest of the level indicator.

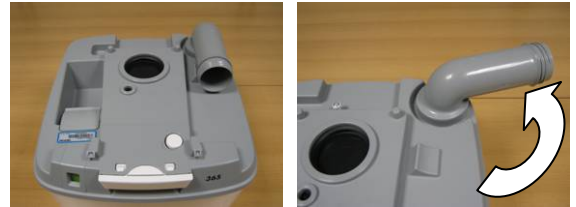
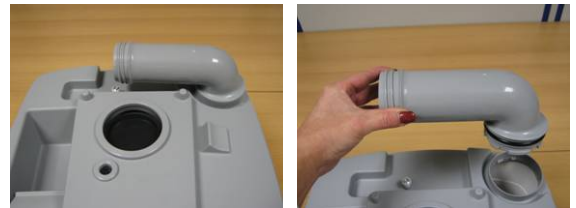
A

Turn the pour out spout and pull it out.

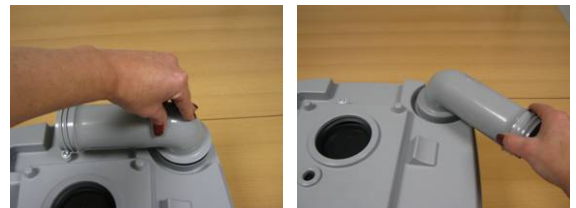
B

Press new pour out spout in and turn it back in position.

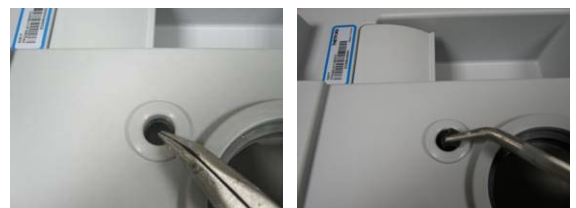
C

By squeezing the new vent seal, it can be pushed through the hole.

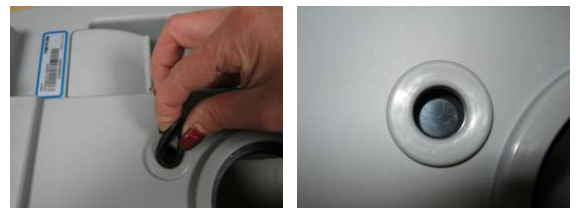
D

Hold vent seal in position with the nose plier while closing the handle slowly. This will press the vent seal back in its groove.

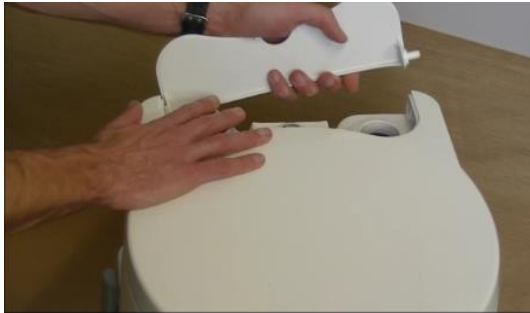
A Remove the small cover to lift the seat en cover of the toilet

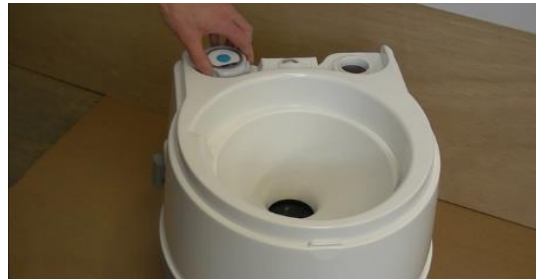
B Turn the knob to the left

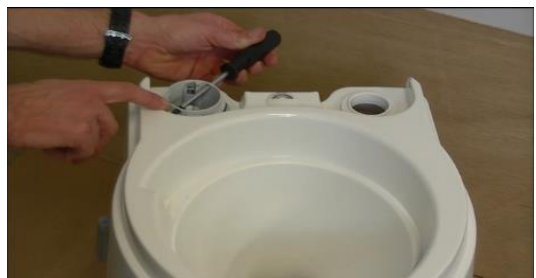
C Use a screwdriver to make a turn to the left.
Now you can lift the pump.

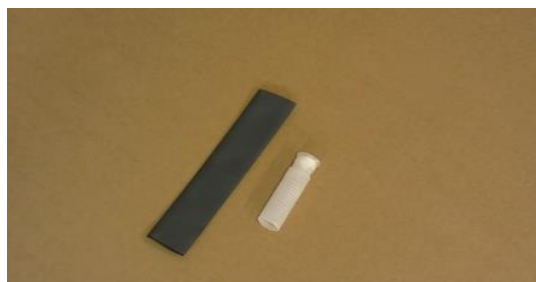
D Unpack the sparepart 92416

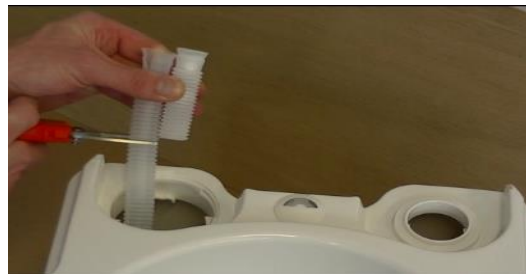
E

Measure the flushtube to the same length as the spare part

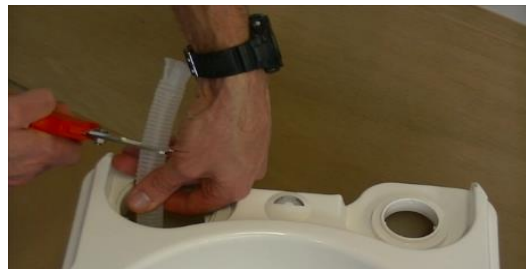
F

Cut the flushtube with the scissors
According the picture

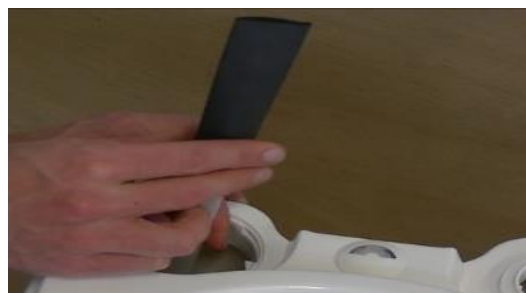
G

Put the shrinktube over the
flushtube

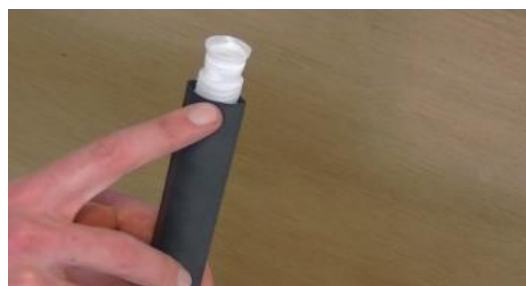
H

Put the spare flushtube(80mm)
into the flushtube.Same height as
on the picture.appr 25 mm

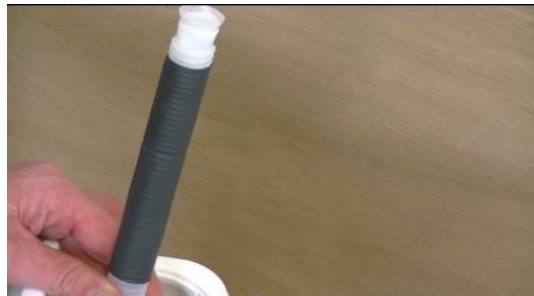
I

Melt the shrinktube with a blow dryer.
Let it cool down for at least 5 minutes

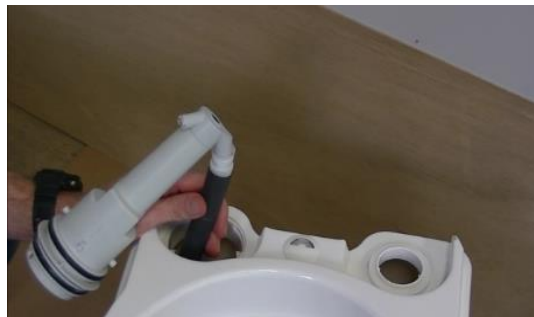
J

Put the flushtube back on the pump and place the pump back in the hole

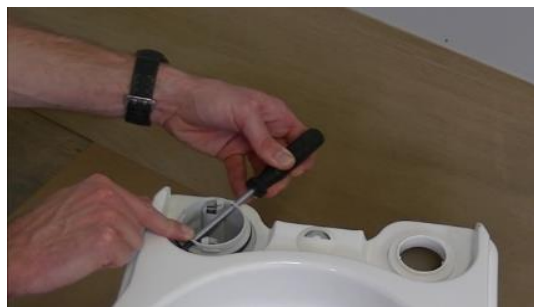
K

Use a screwdriver to turn the pump housing to the right

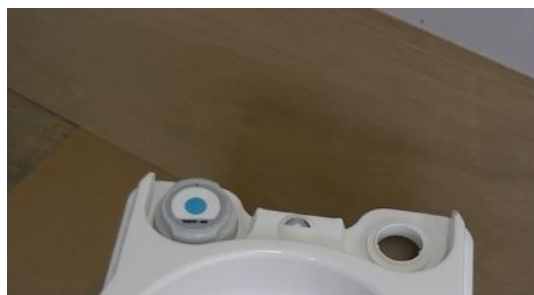
L

Place the knob back and turn to the right

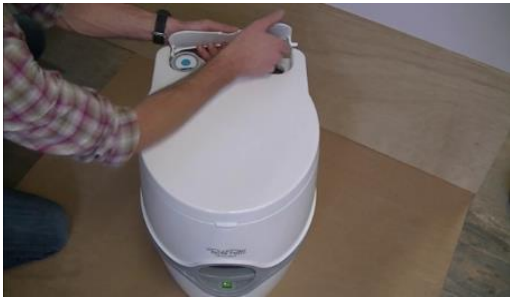
M

Put the seat en cover back on the toilet
